**Town of Summerville
Tree Protection Board Meeting
June 8, 2020 – 9:00 am
Town Hall, Town Council Chambers**

STAFF REPORT
Tree Protection Committee Meeting
June 1, 2020

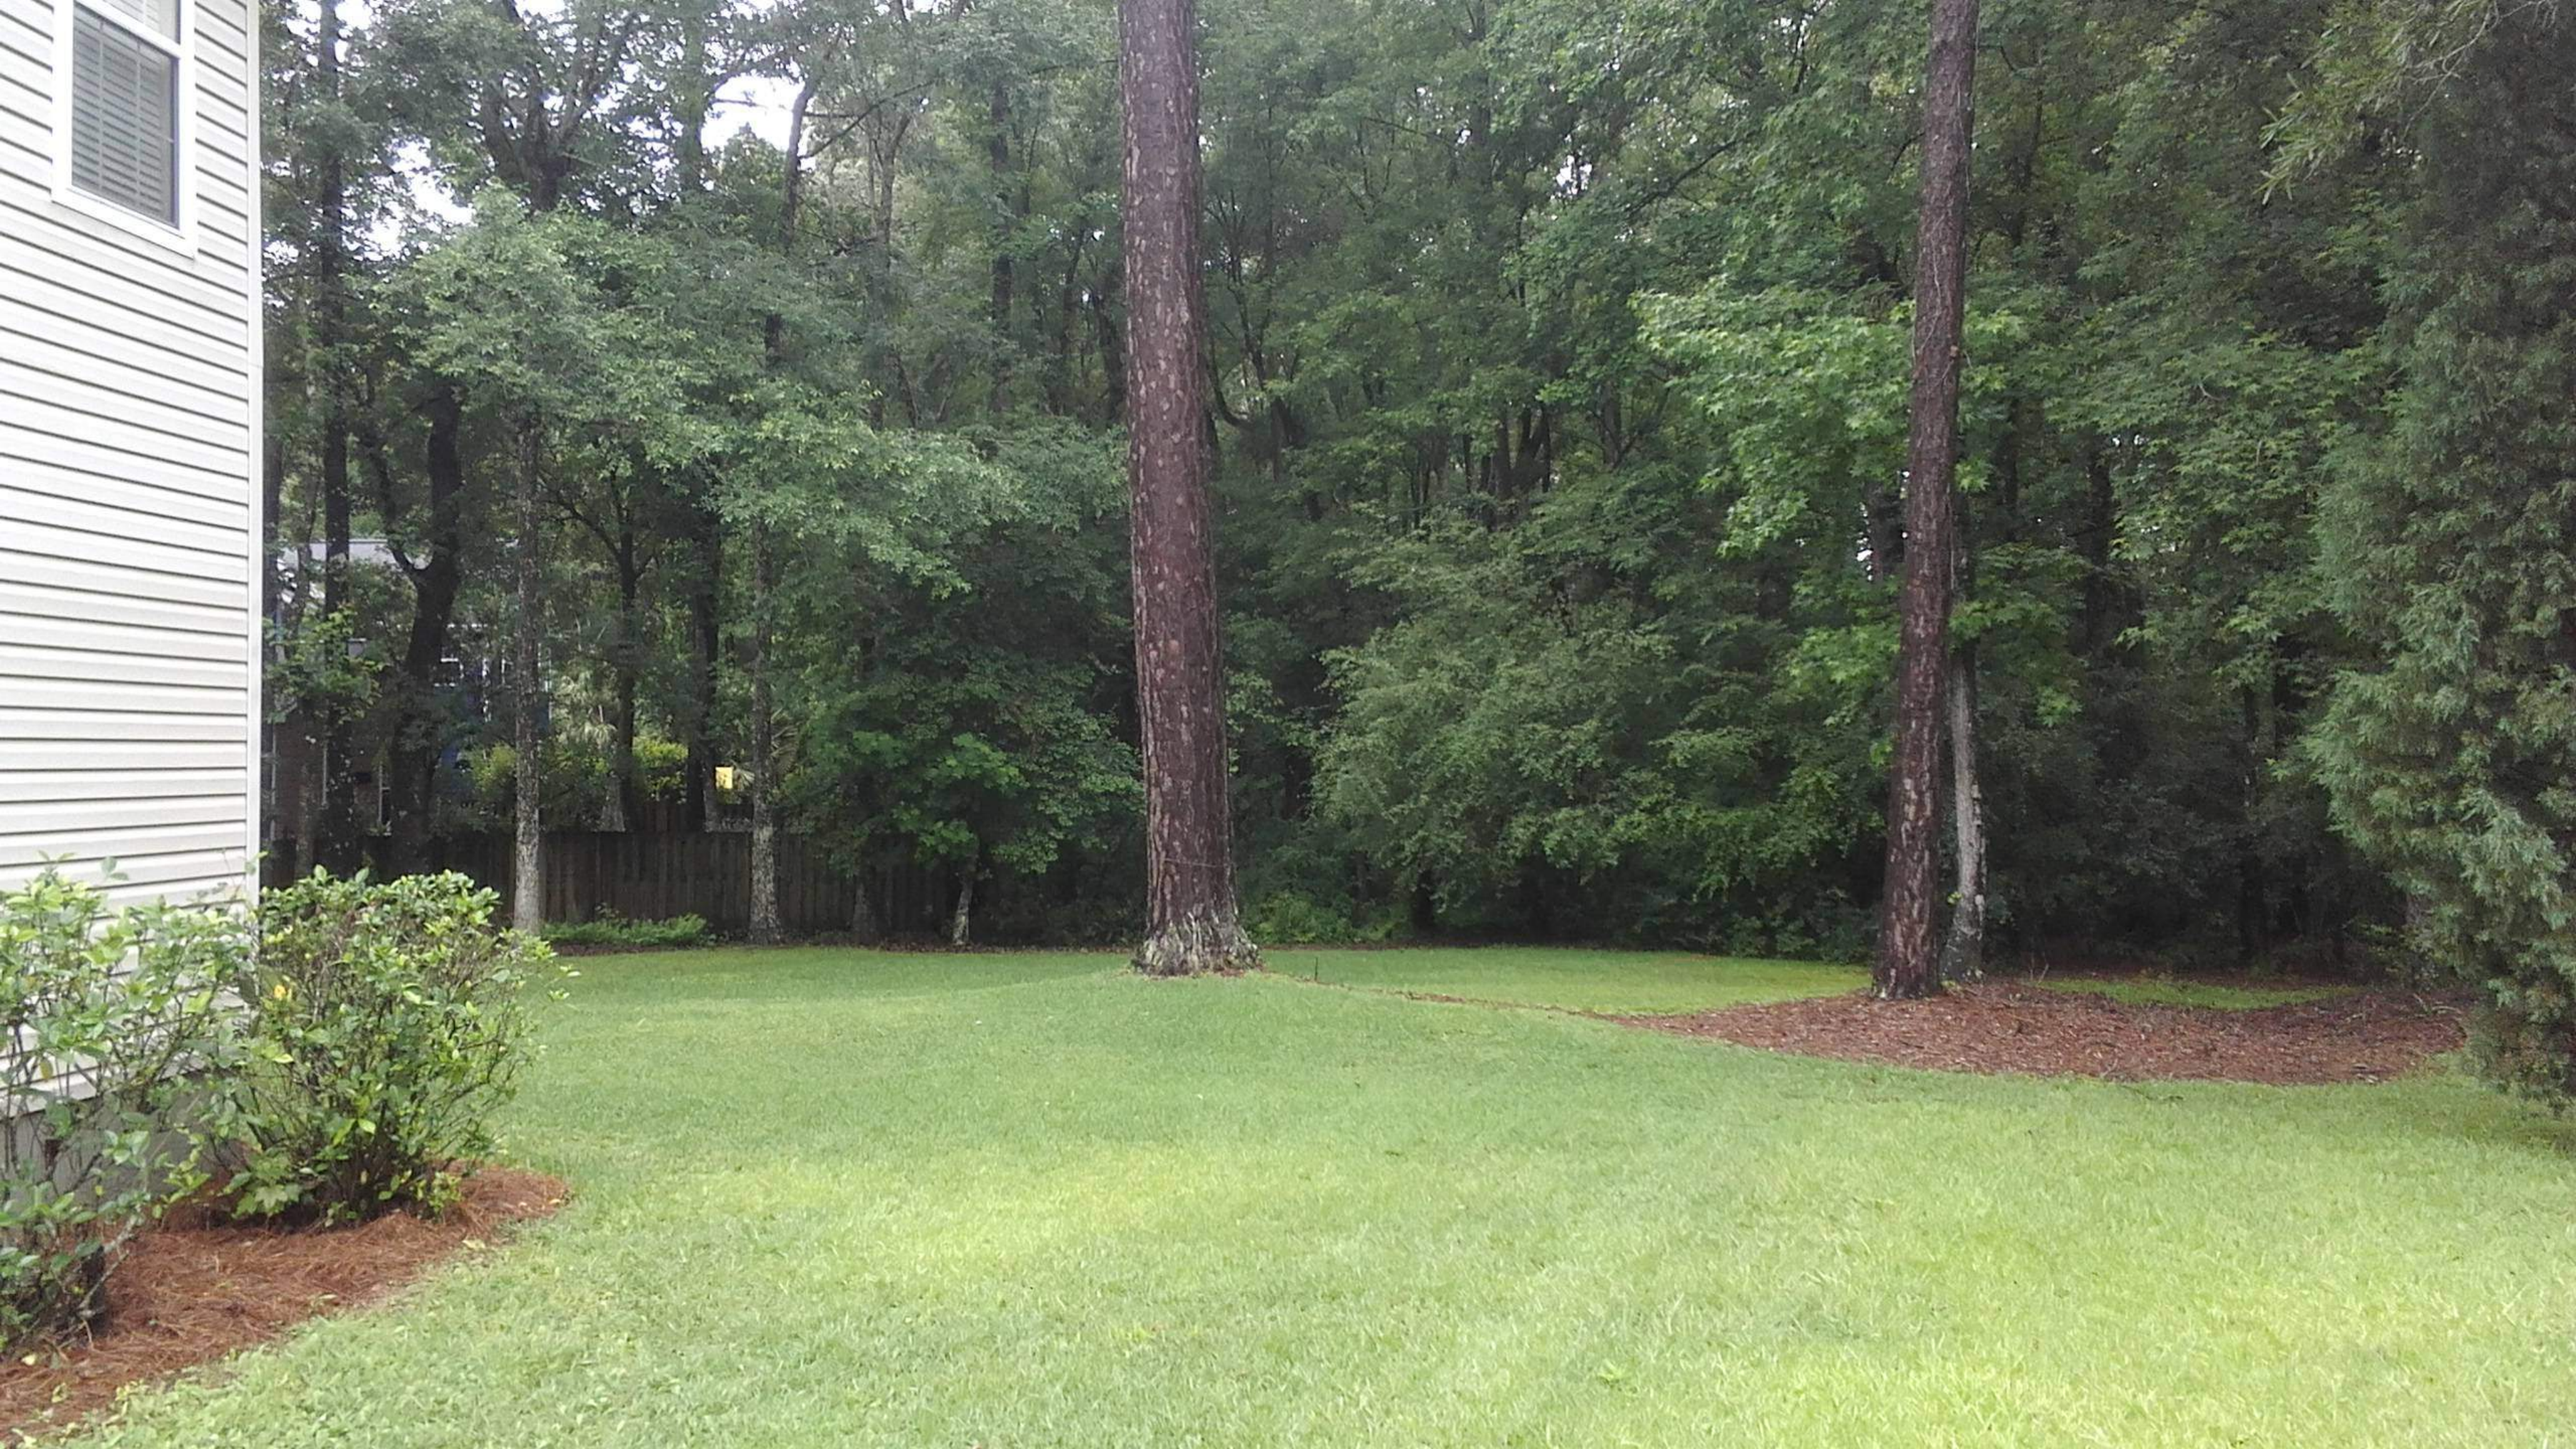
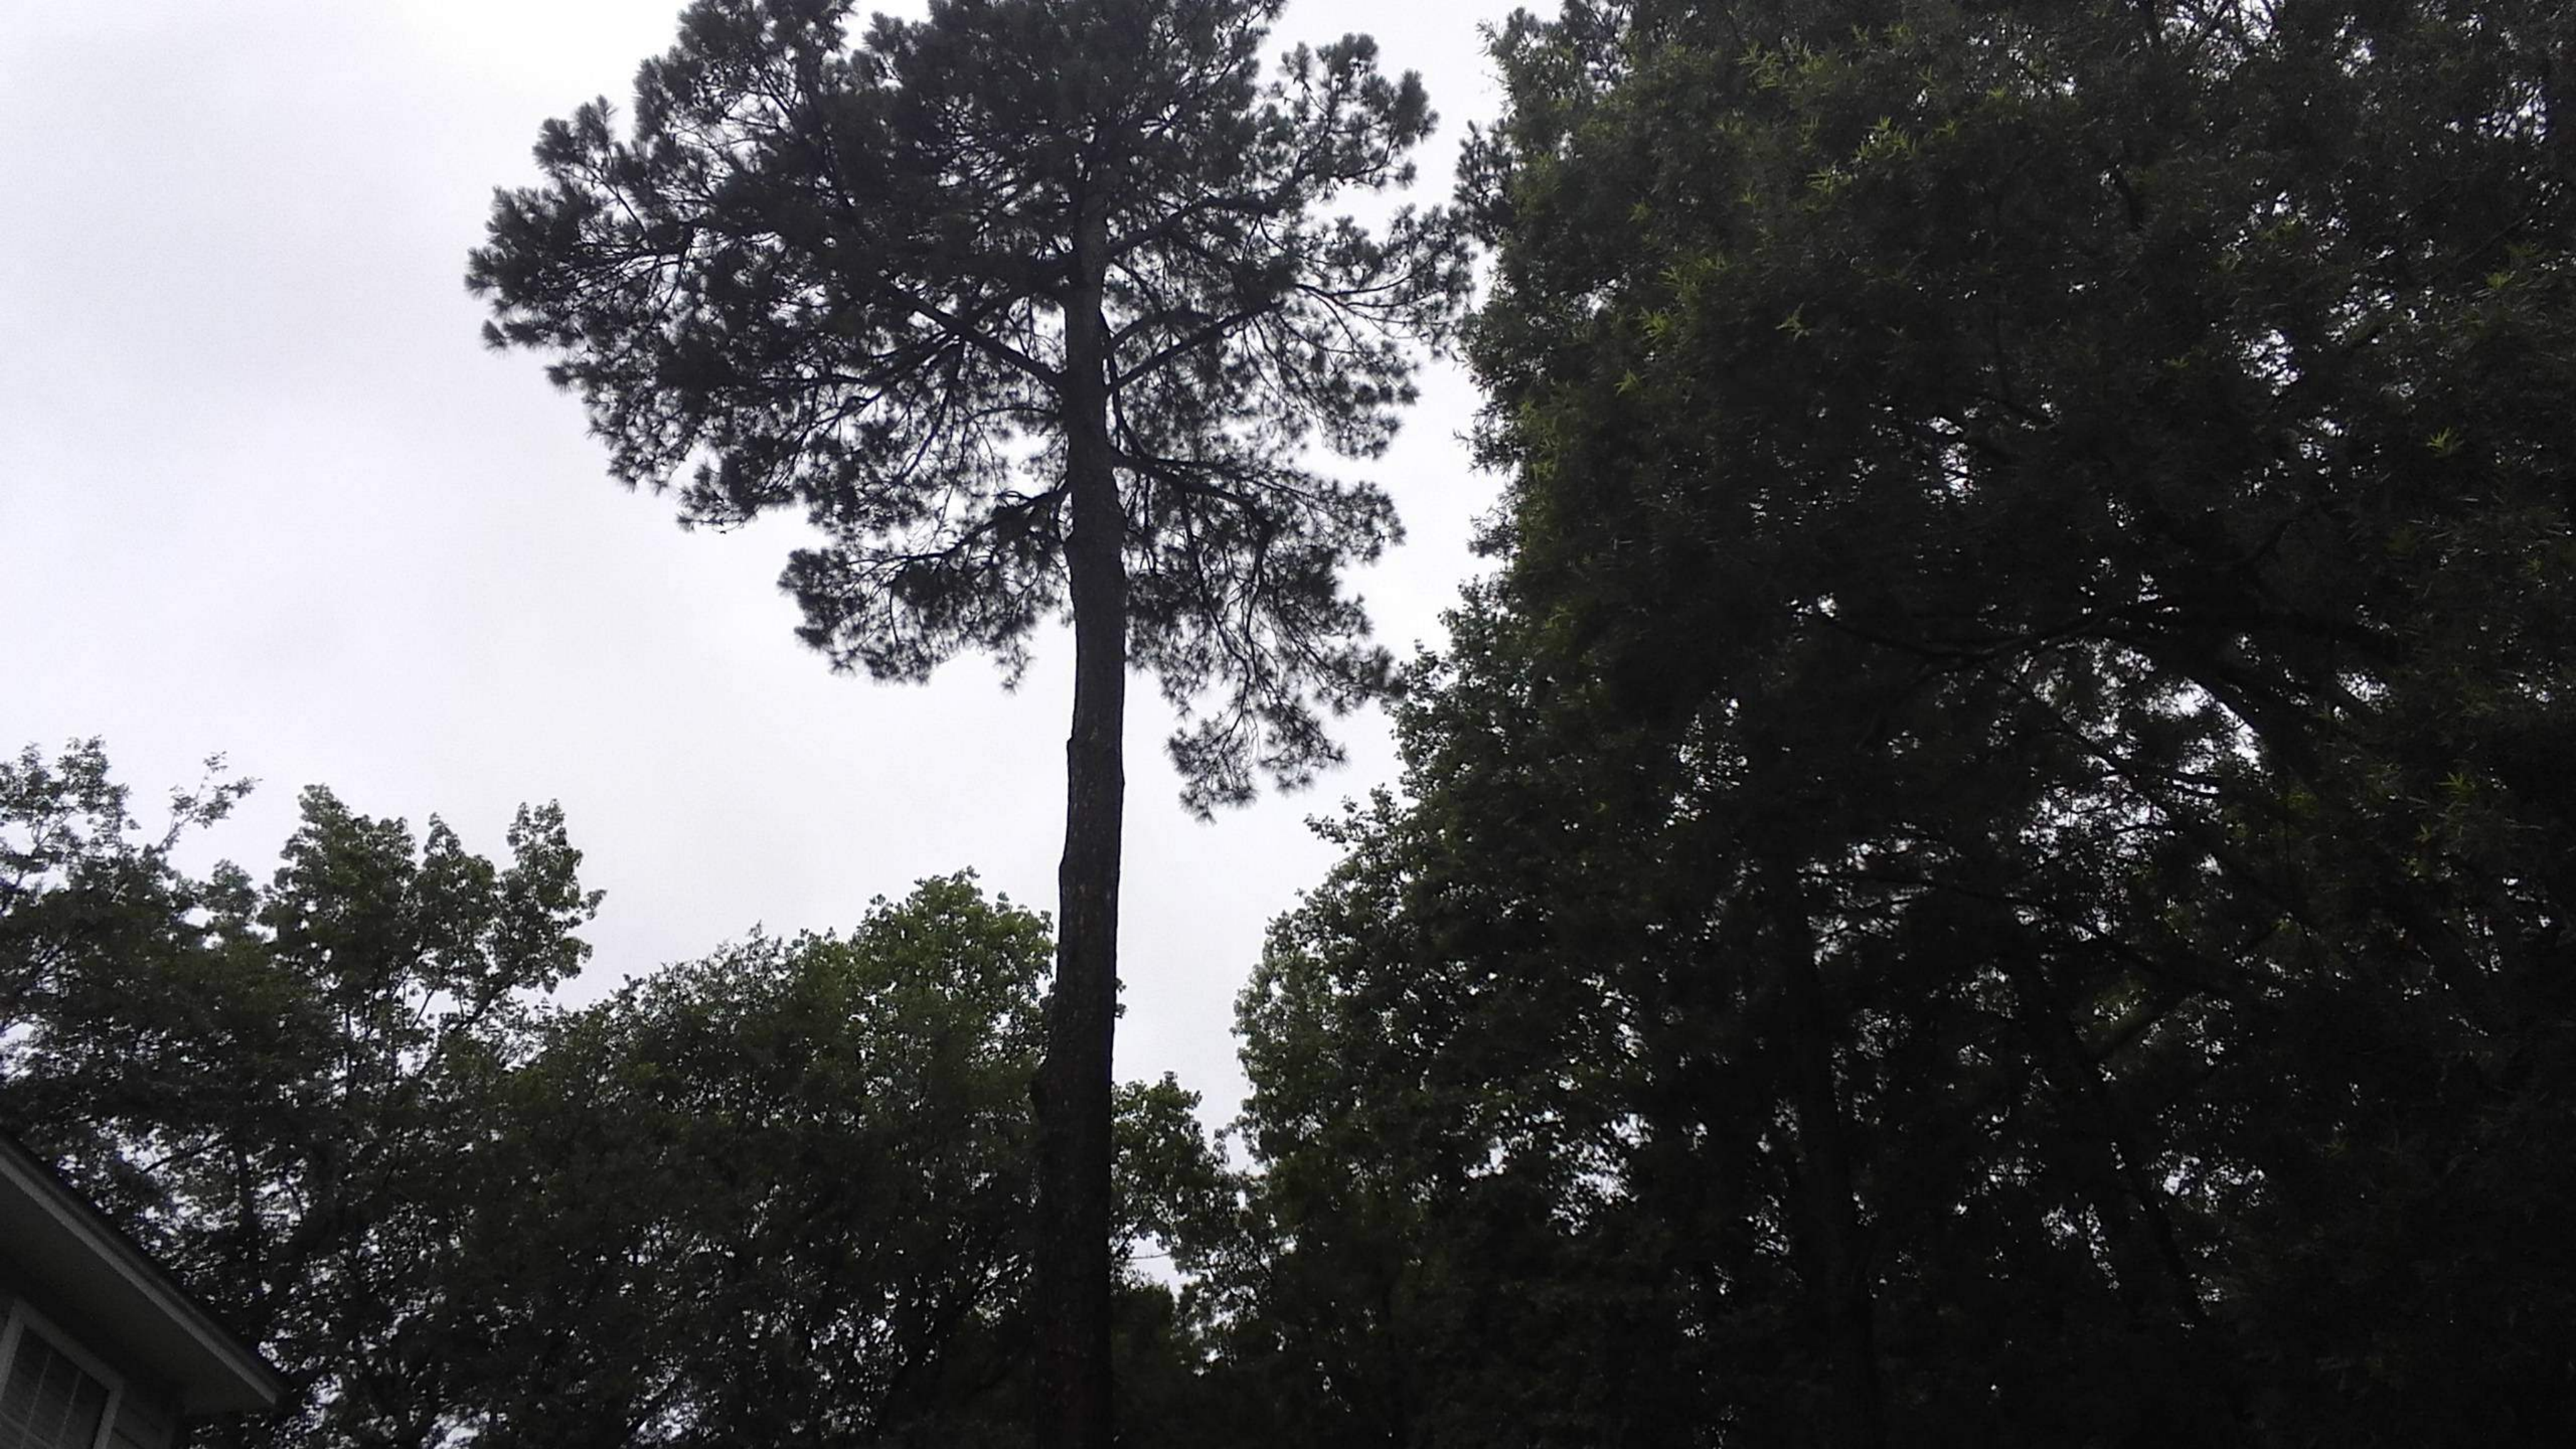
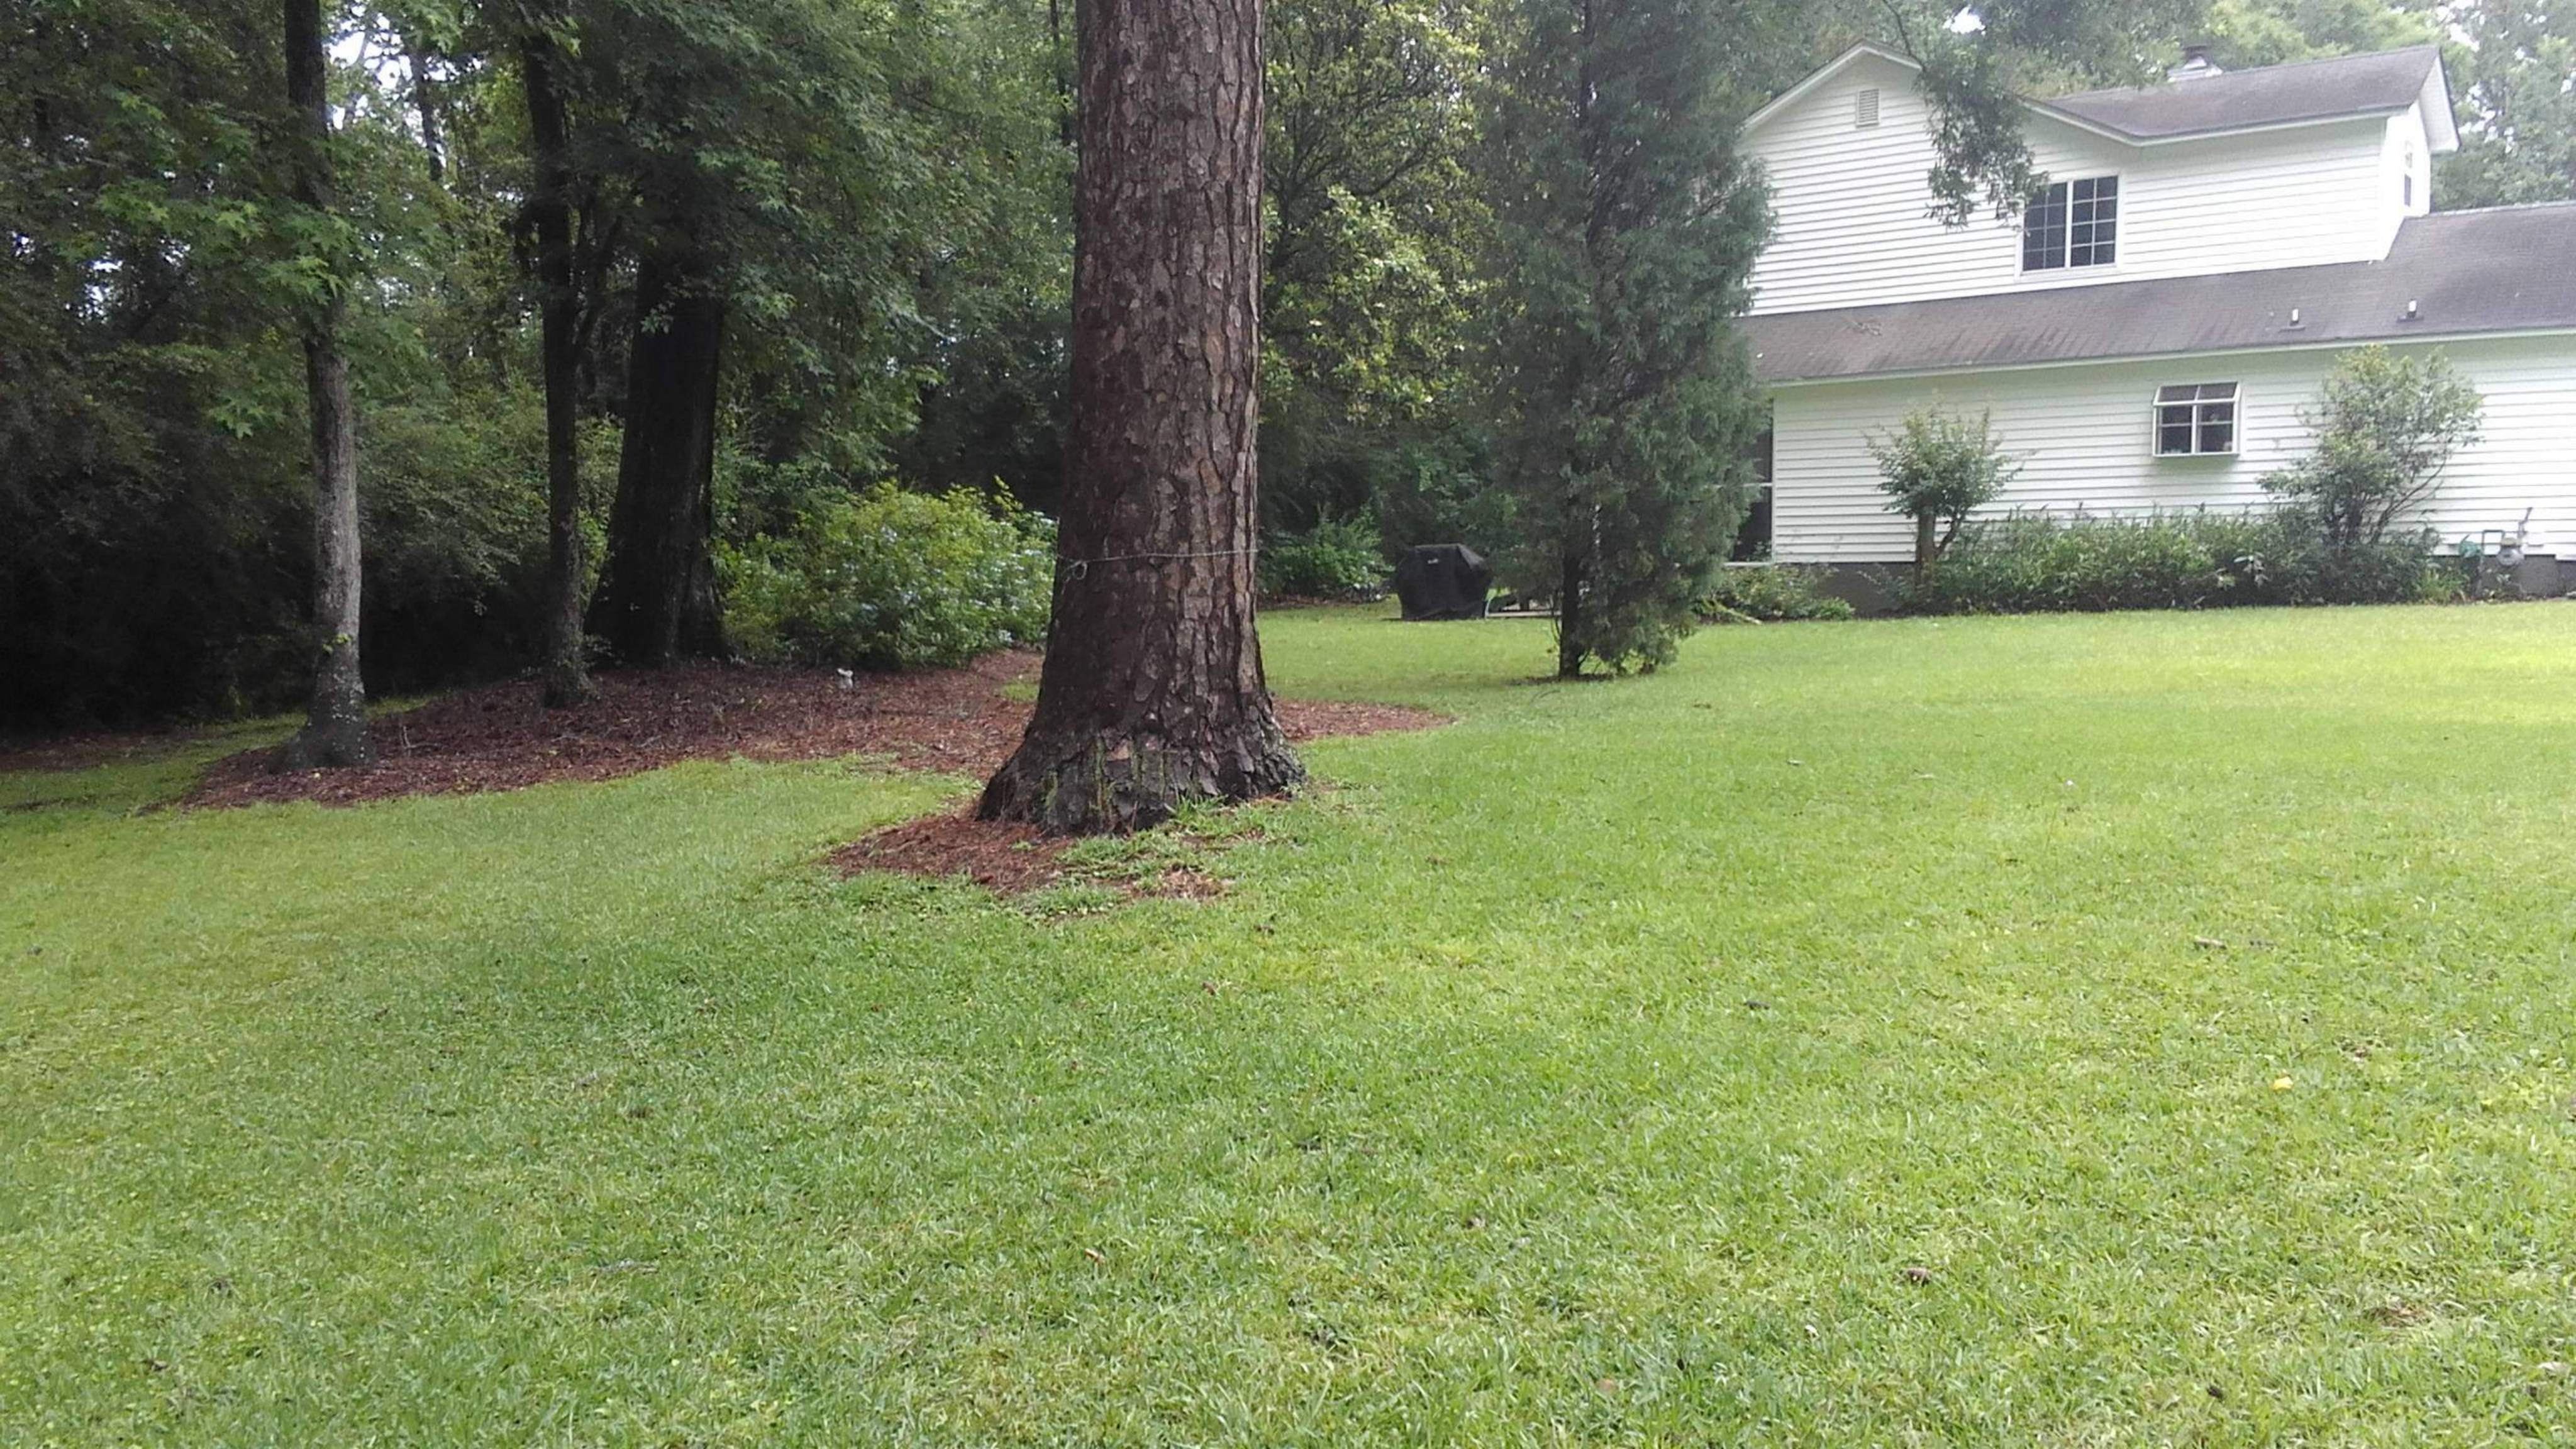
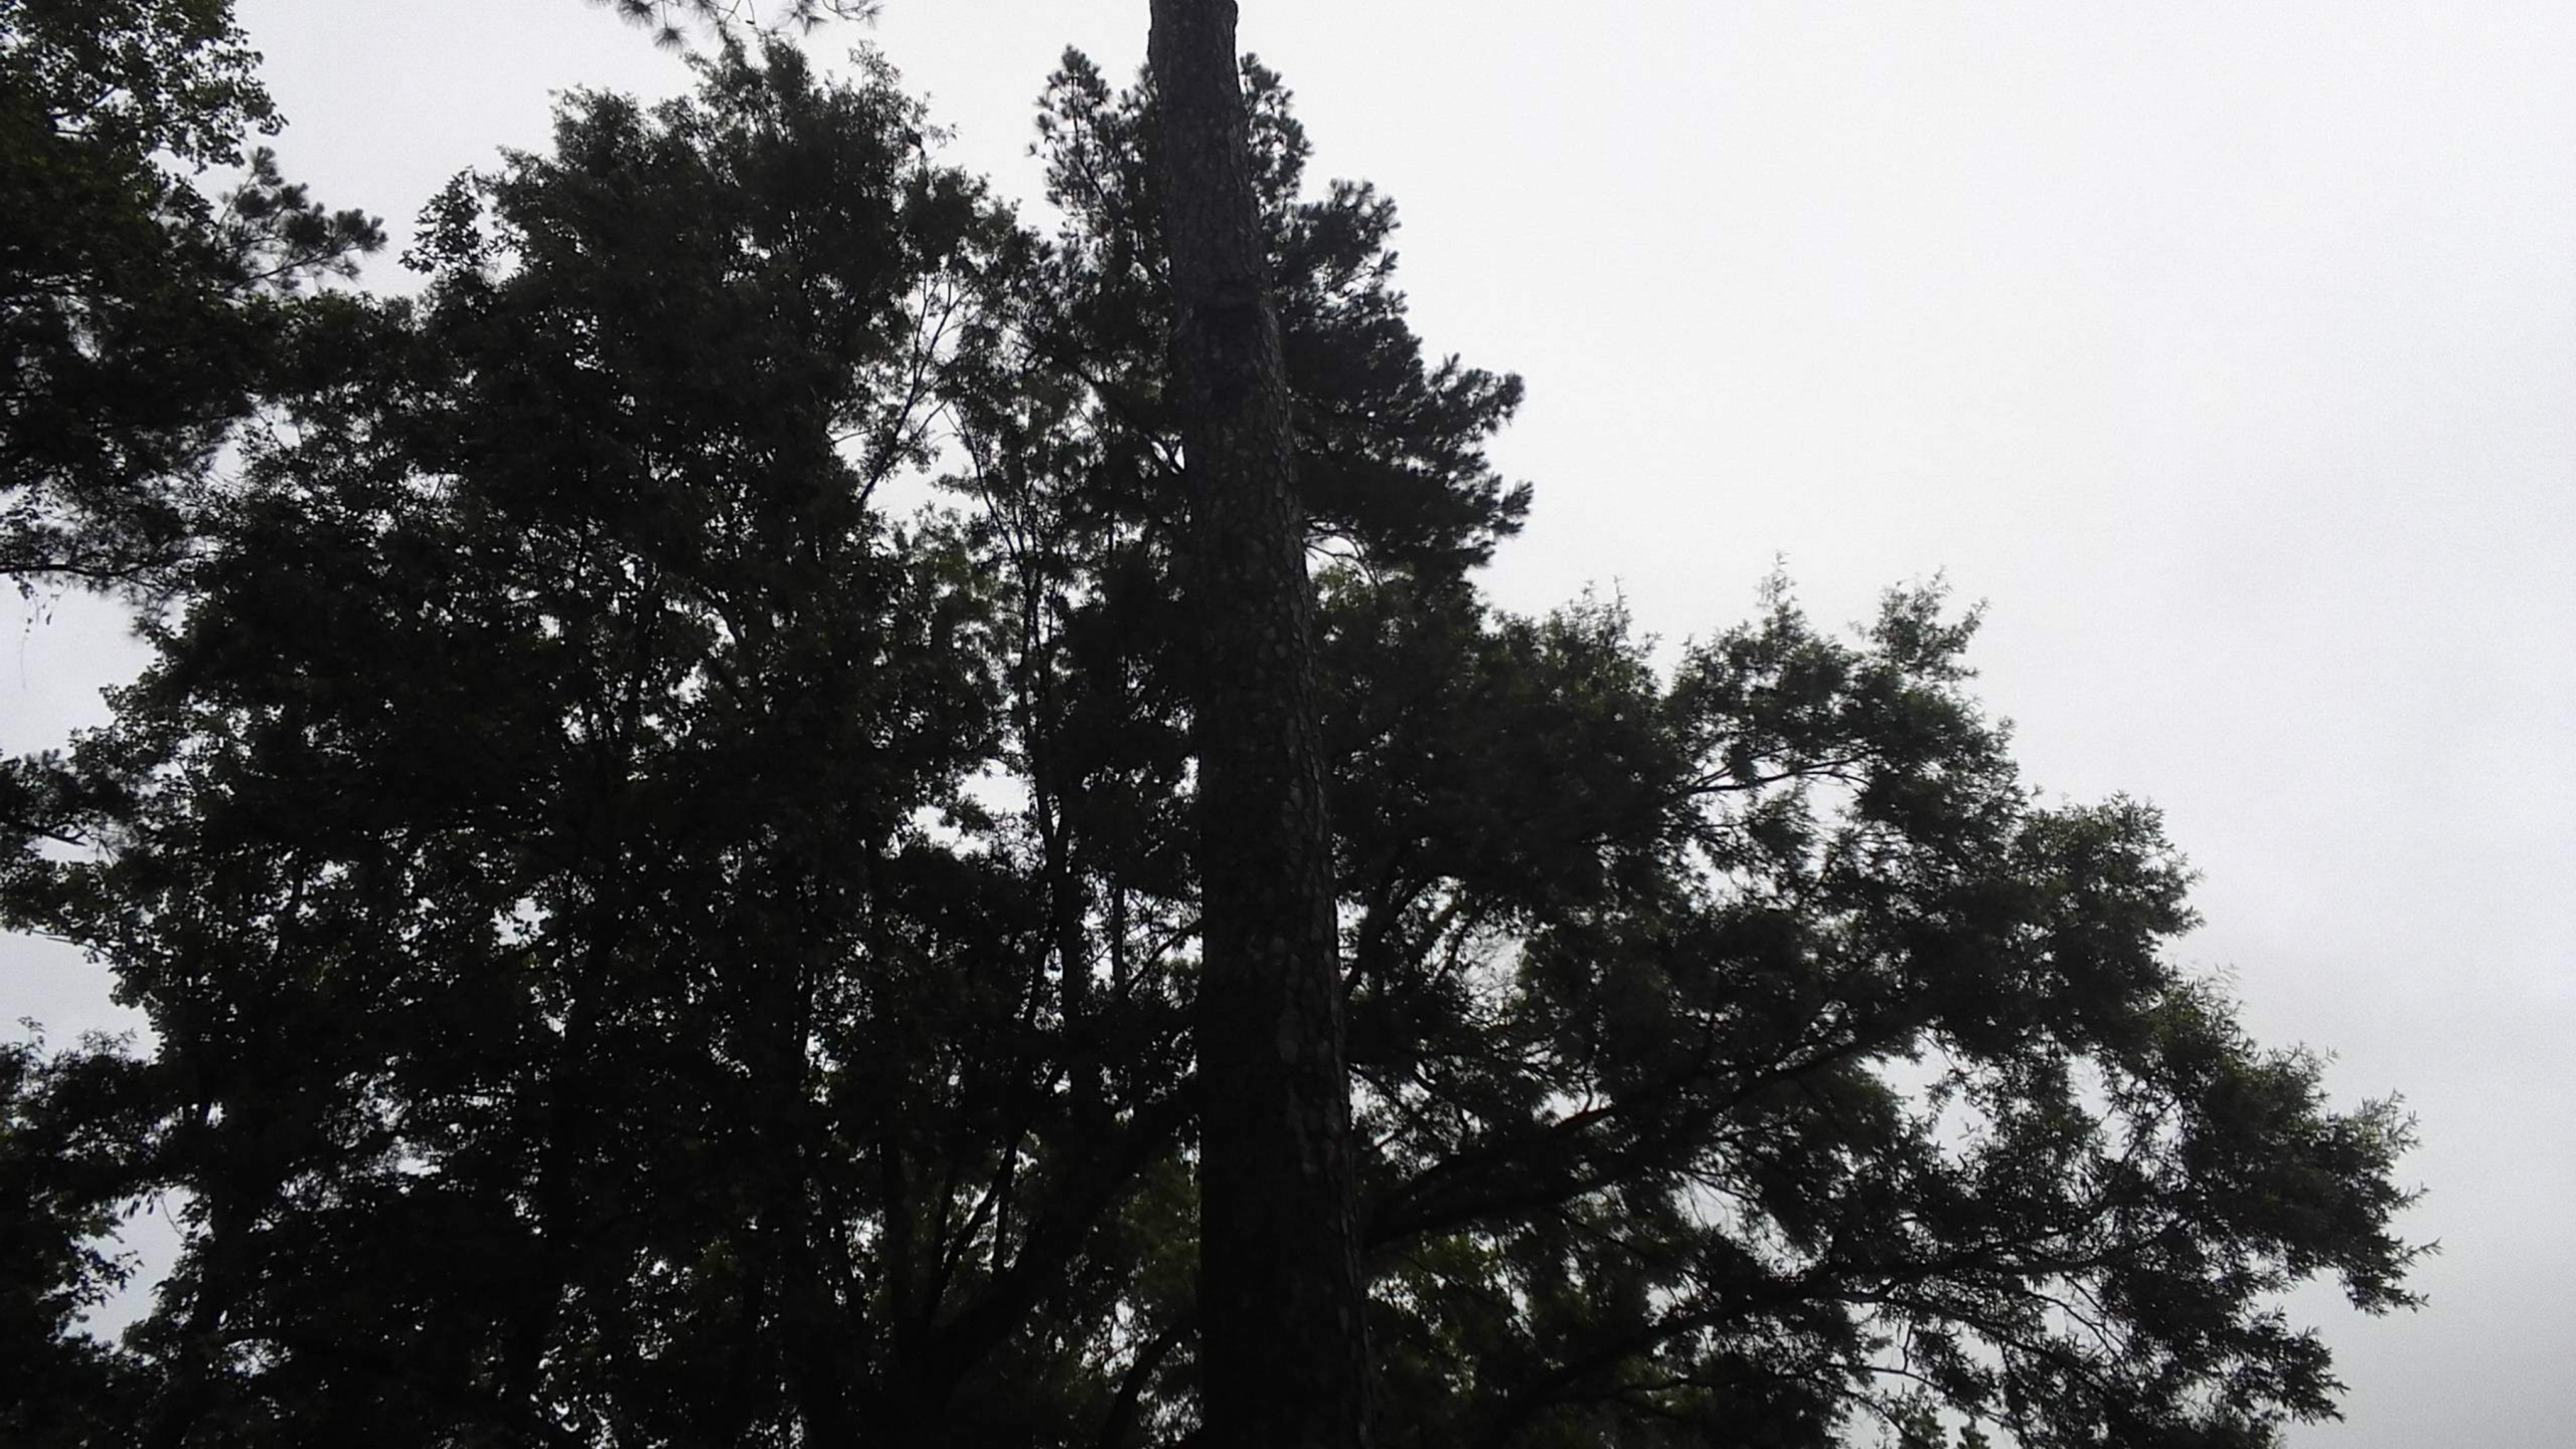
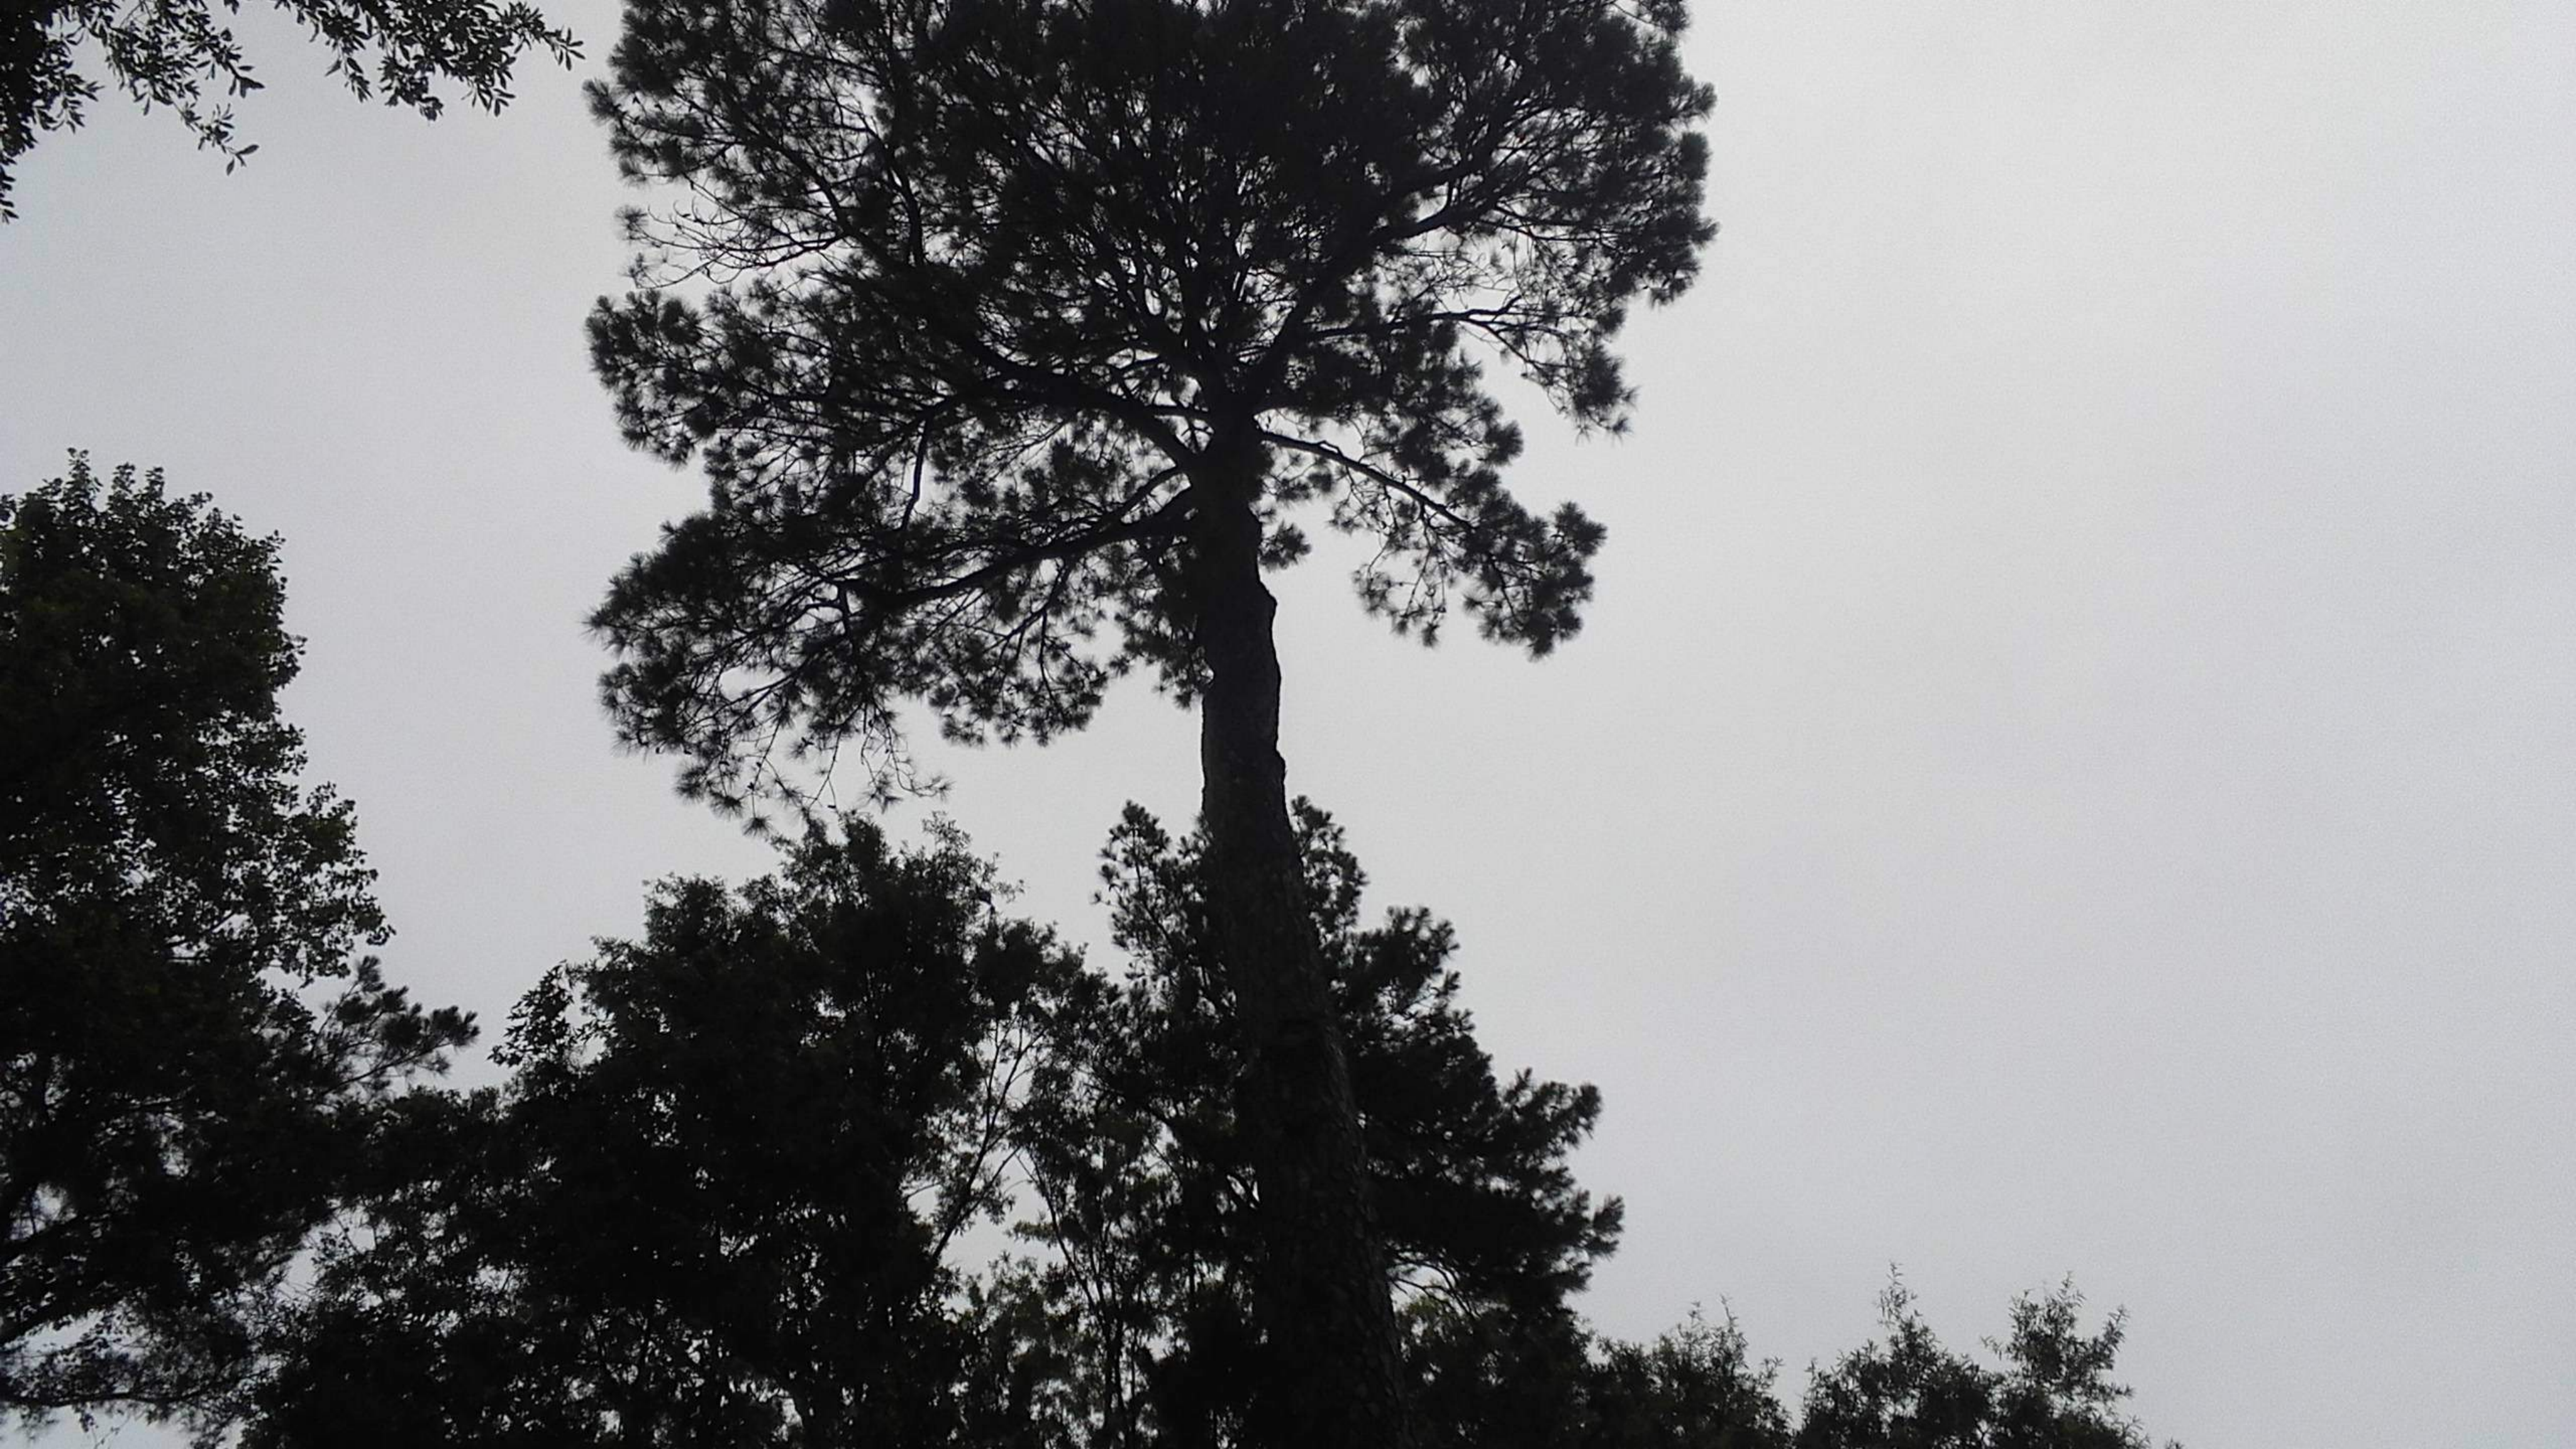
192 Factors Walk

History of failures lower limbs are missing Topography Flat ☐ Slope ☒ 3 % Aspect _____
 Site changes None ☐ Grade change ☒ Site clearing ☐ Changed soil hydrology ☐ Root cuts ☐ Describe Tree sits up high
 Soil conditions Limited volume ☐ Saturated ☐ Shallow ☐ Compacted ☐ Pavement over roots ☐ % Describe lime
 Prevailing wind direction _____ Common weather Strong winds ☒ Ice ☐ Snow ☐ Heavy rain ☒ Describe thunder storms

Vigor Low ☐ Normal ☒ High ☒ Foliage None (seasonal) ☐ None (dead) ☐ Normal 90 % Chlorotic 10 % Necrotic 0 %
 Pests/Biotic wood pecker Abiotic _____
 Species failure profile Branches ☒ Trunk ☐ Roots ☐ Describe pine tree self pruned limbs

Unbalanced crown ☐ LCR _____ %
 Dead twigs/branches ☐ _____ % overall Max. dia. _____
 Broken/Hangers Number _____ Max. dia. _____
 Over-extended branches ☐
 Pruning history
 Crown cleaned ☐ Thinned ☐ Raised ☒
 Reduced ☐ Topped ☐ Lion-tailed ☐
 Flush cuts ☐ Other _____
it has a hole up high where Condition(s) of concern _____
branch had been cut
